MOECKEL DAM
WASHINGTON COUNTY, MISSOURI
MO 30476

PHASE 1 INSPECTION REPORT NATIONAL DAM SAFETY INSPECTION

DECEMBER 1980

SUBJECT: Moeckel Dam Phase I Inspection Report

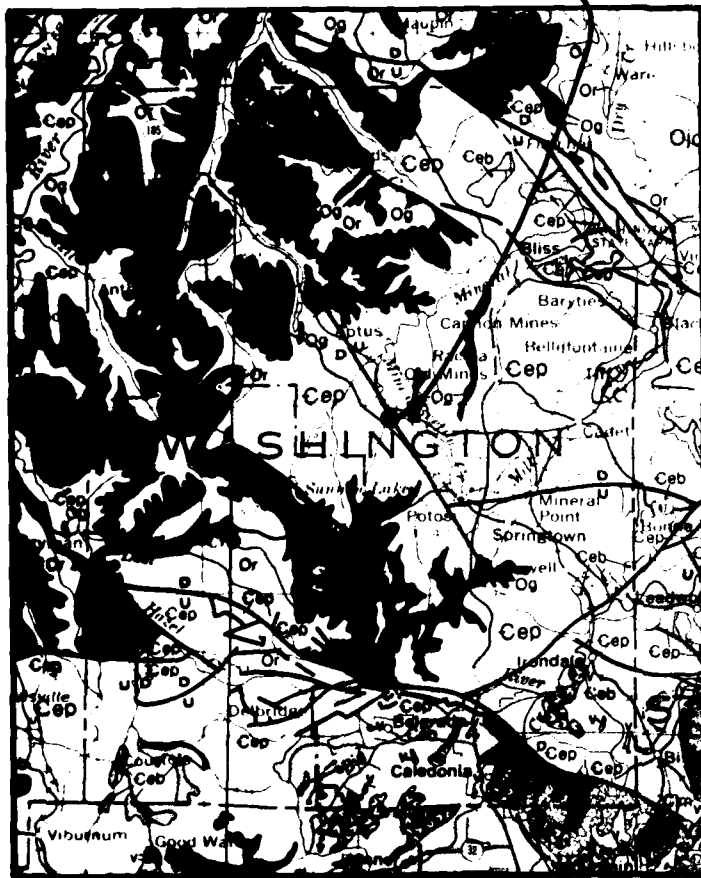
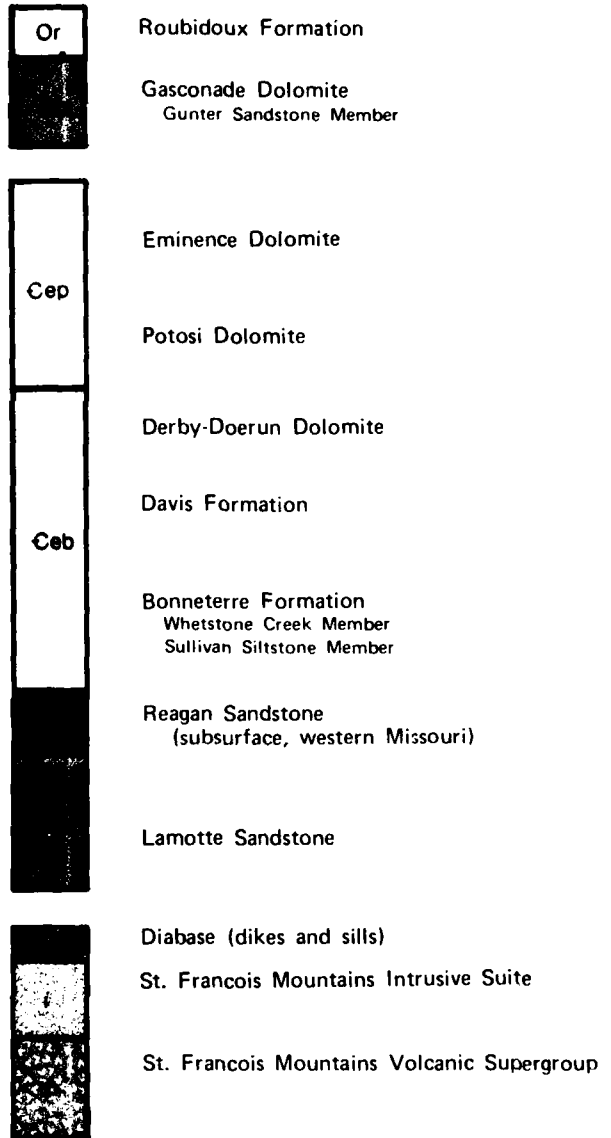
Fig. 4

The dam is located on the northern flank of the Ozark structural dome. The bedrock in the area is mapped on the Geologic Map of Missouri (1979) as Potosi and Eminence dolomite formations (Fig 4). The Potosi Formation consists of light gray, medium- to fine-grained siliceous dolomite and typically contains an abundance of quartz druse characteristic of chert bearing formations. The Eminence Formation conformably overlies the Potosi Formation, is similar in appearance but contains less chert and quartz. Some large springs and caves have been noted in the Eminence Formation in other parts of Missouri; however, no evidence of springs or solution activity was noted during the visual inspection of the dam site.

The Aptus Fault is mapped on the Geologic Map of Missouri (1979) approximately 3/4 mi southwest of the dam (Fig 4). However, the scale of the map (1 in. equals 8 mi) does not allow for precise location of the fault trace. No evidence of the fault was noted during the field inspection. The fault is approximately 15 miles long, trending northwest-southeast, and is mapped as northeast side up.

This fault, like others in the Ozark region, appears confined to the Paleozoic bedrock and is likely Paleozoic in age. The area is not considered seismically active, and the fault is not considered to pose a significant hazard to the dam.
